Thermographic Report

Company: ABC Company
Site Location: Site A
Thermographer: Mr. Ian Checkley
Date: 20/09/05

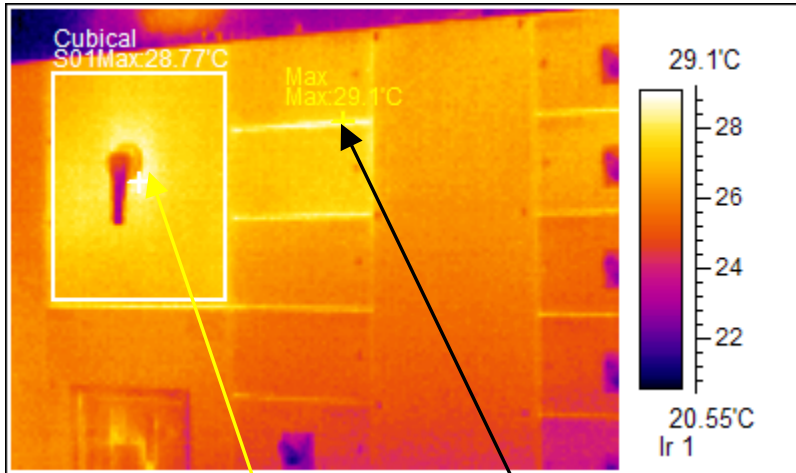
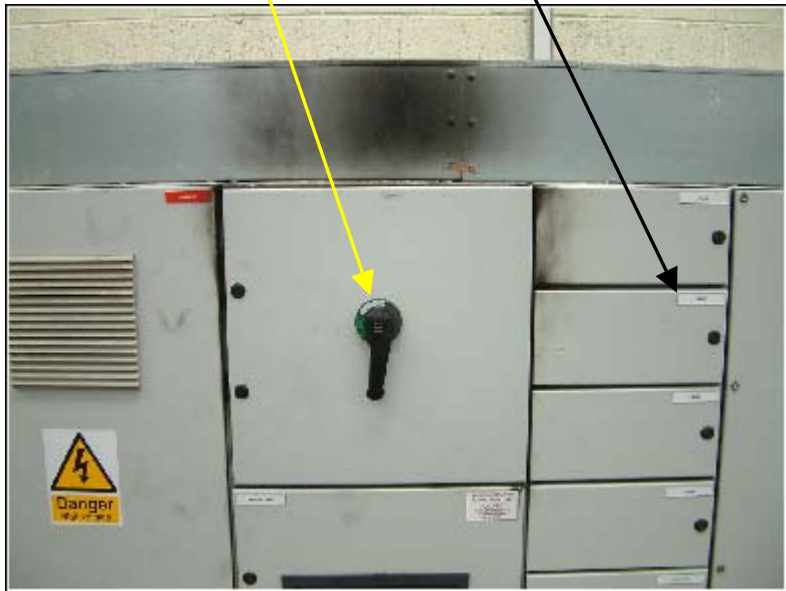
IR Info	Value
IrNo	1
ems	0.95
dist	1
Title	Switch fuse compartment
Date	2005-9-20
Time	9:7:31
Operator	Ian Checkley
Max	29.1
Min	20.55
Description	
Label	Value
Max:Temp	29.1

Conditions: Normal

Fault: Increased energy is still present on this switch fuse cubical. But also in this picture another anomaly is present again in the spare cubical.

Action required: Please investigate this spare cubical further to establish the reason for this temperature rise.

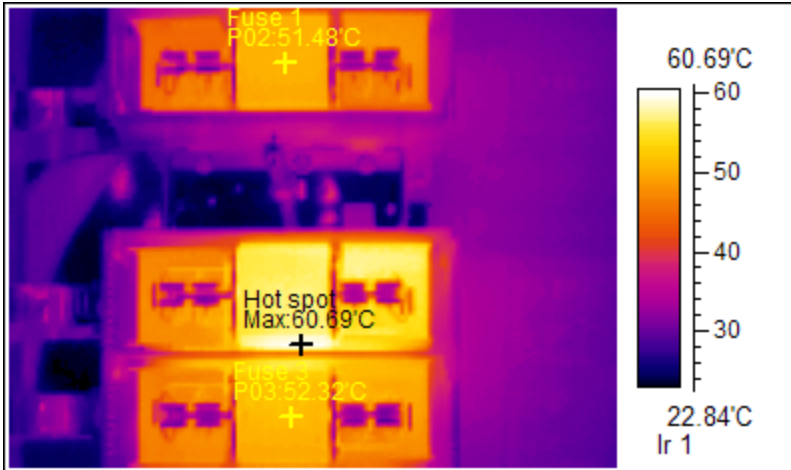
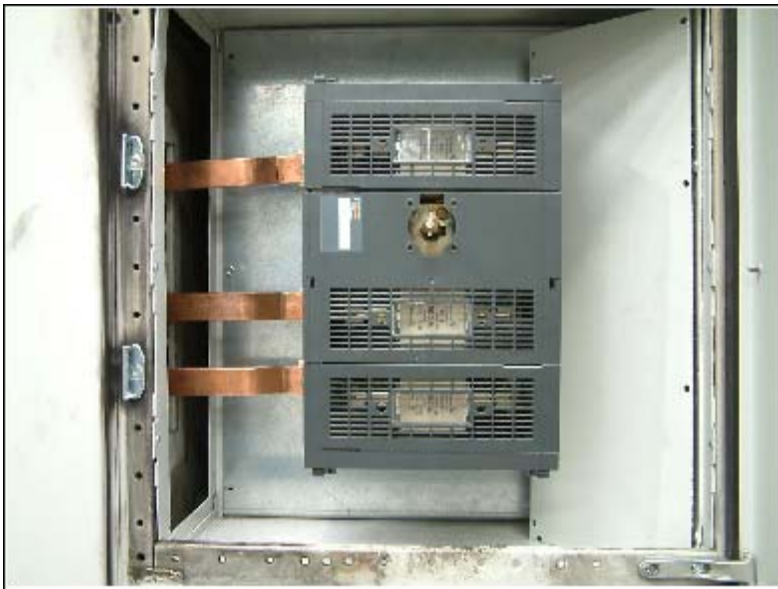
IR Info	Value
IrNo	1
ems	0.95
dist	1.5
Title	Switch Fuse
Date	2005-9-20
Time	9:12:41
Operator	Ian Checkley
Max	60.69
Min	22.84
Description	
Label	Value
Max:Temp	60.69
P02:Temp	51.48
P03:Temp	52.32

Conditions: Normal

Load Fuse 1: 308 amp
Load Fuse 2: 220 amp
Load Fuse 3: 311 amp

Fault: The middle fuse is running at almost 10C above the other two fuses.

Action required: Please check the load distribution through the PF unit to establish if this load should be balanced.
